Final After Action Report For North Lobe Dredging

New Bedford Harbor Superfund Site Operable Unit No. 1 New Bedford, MA

May 2005

Doc. No. 2005-24-0011 | 14.8

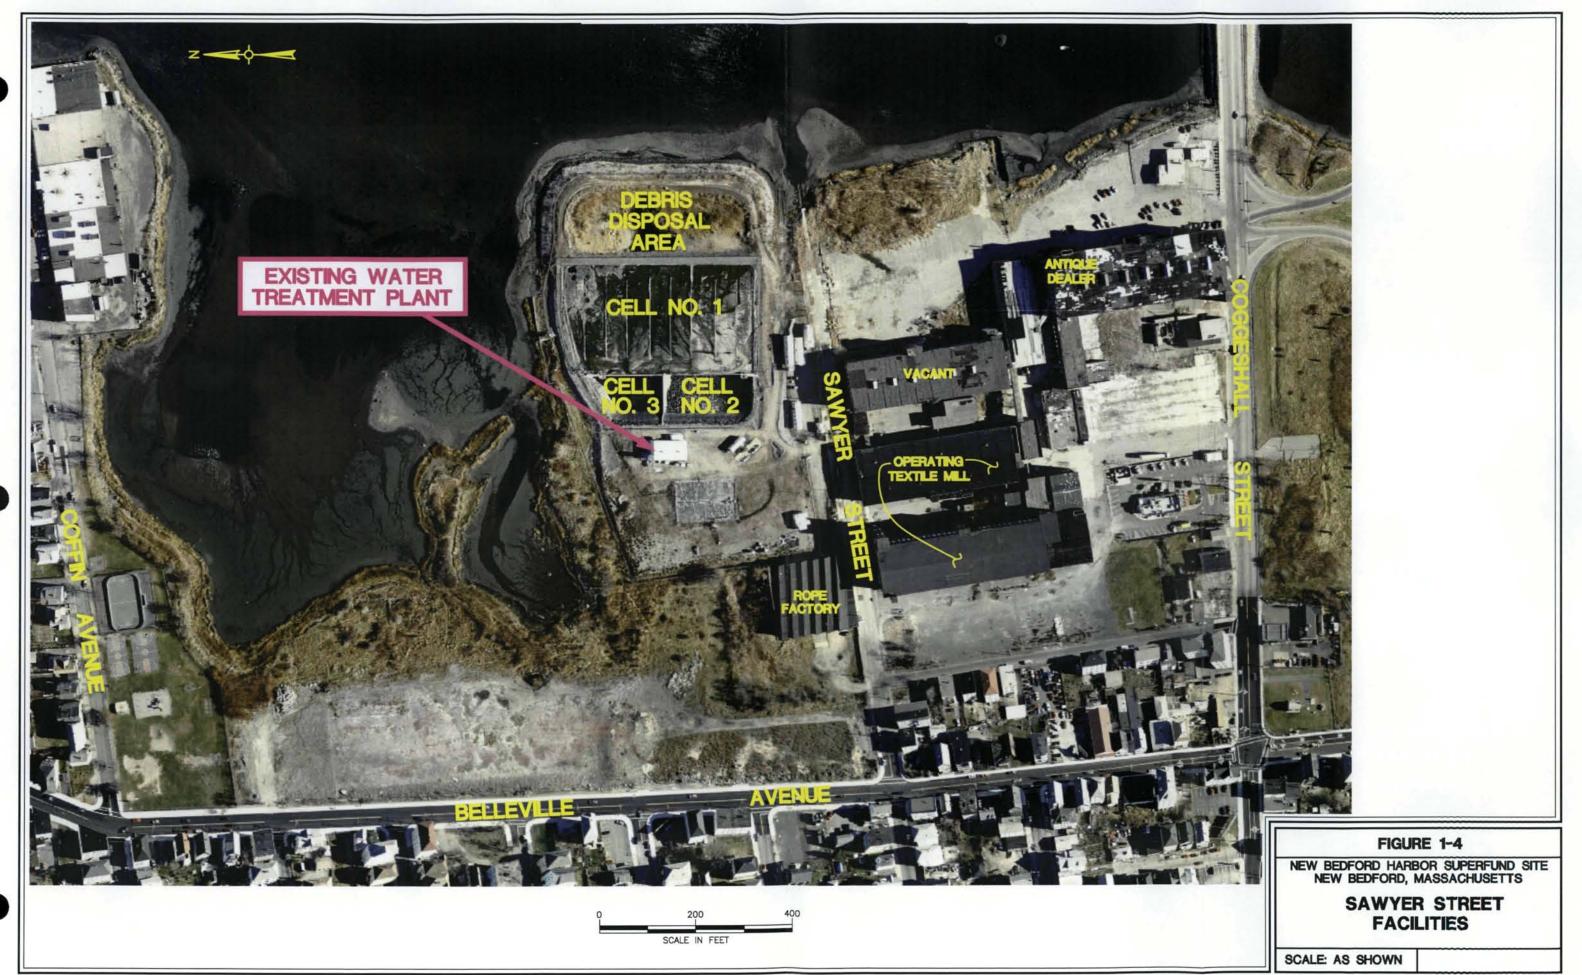
The dredged materials were transported in scows from the North Lobe area to the existing facilities at Sawyer Street. Refer to Figure 1-4 for layout of the Sawyer Street Facilities. The dredged material was offloaded from the scows and transported to the DDA. The debris was separated from the dredged sediments and placed in the DDA. The dredged sediments were pumped into Cell No. 1 for future processing and disposal.

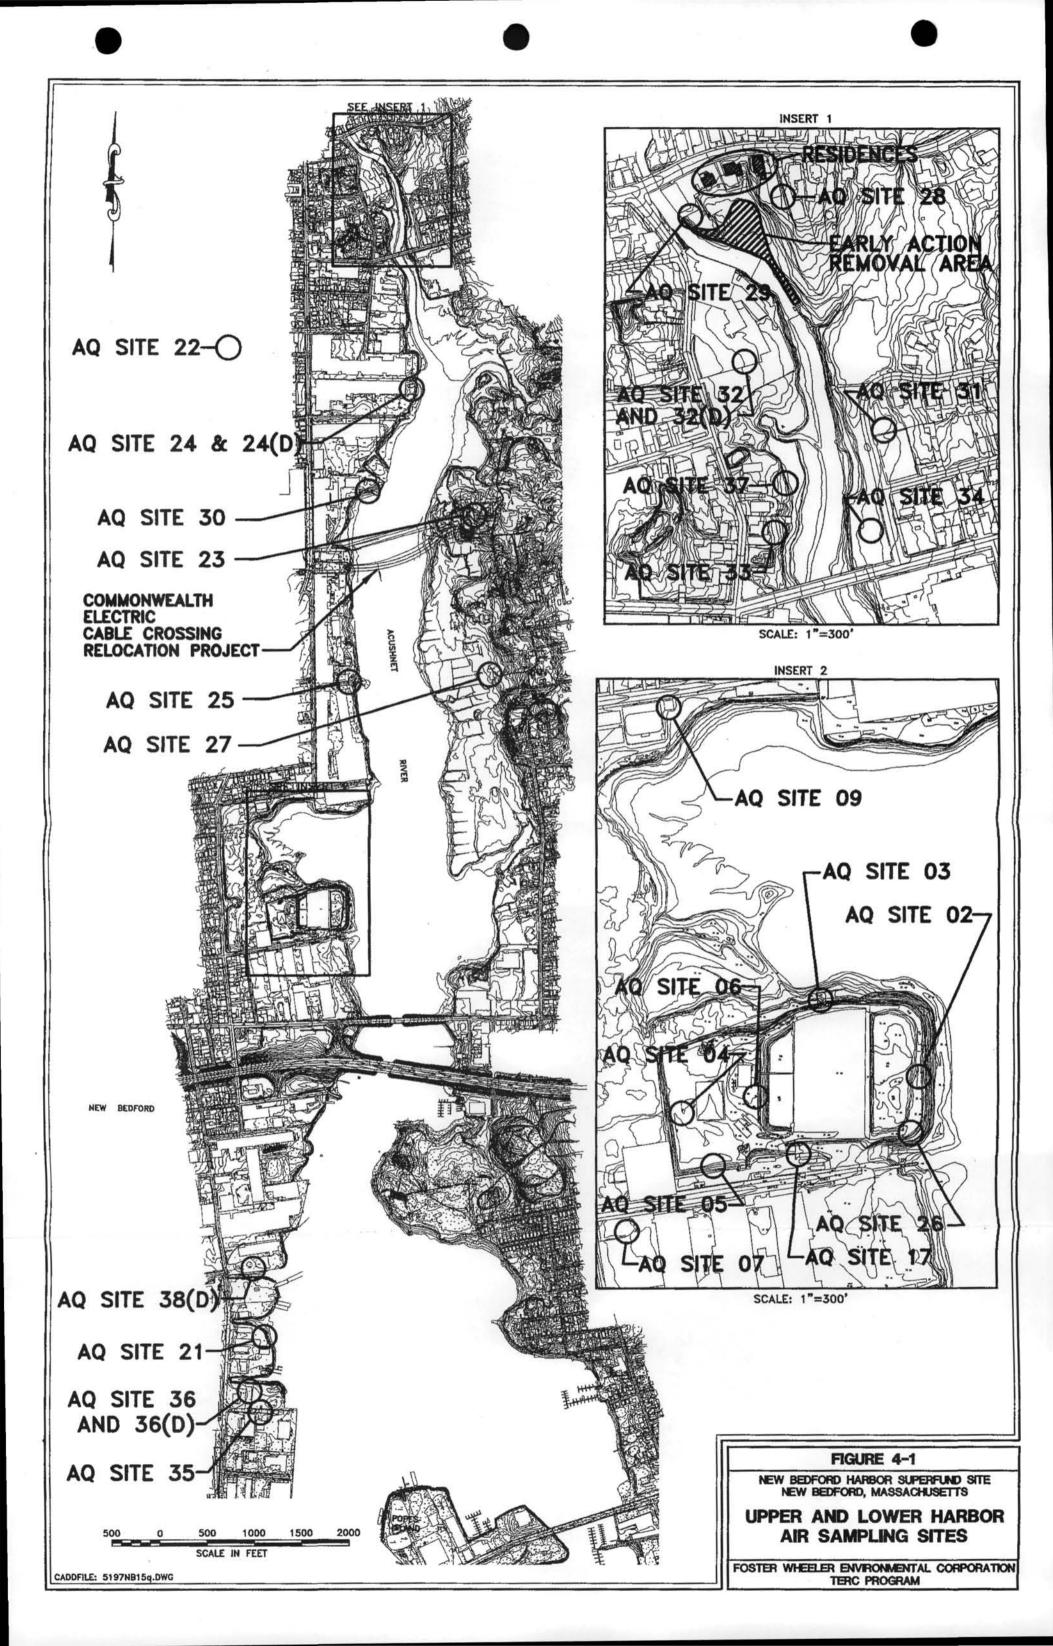
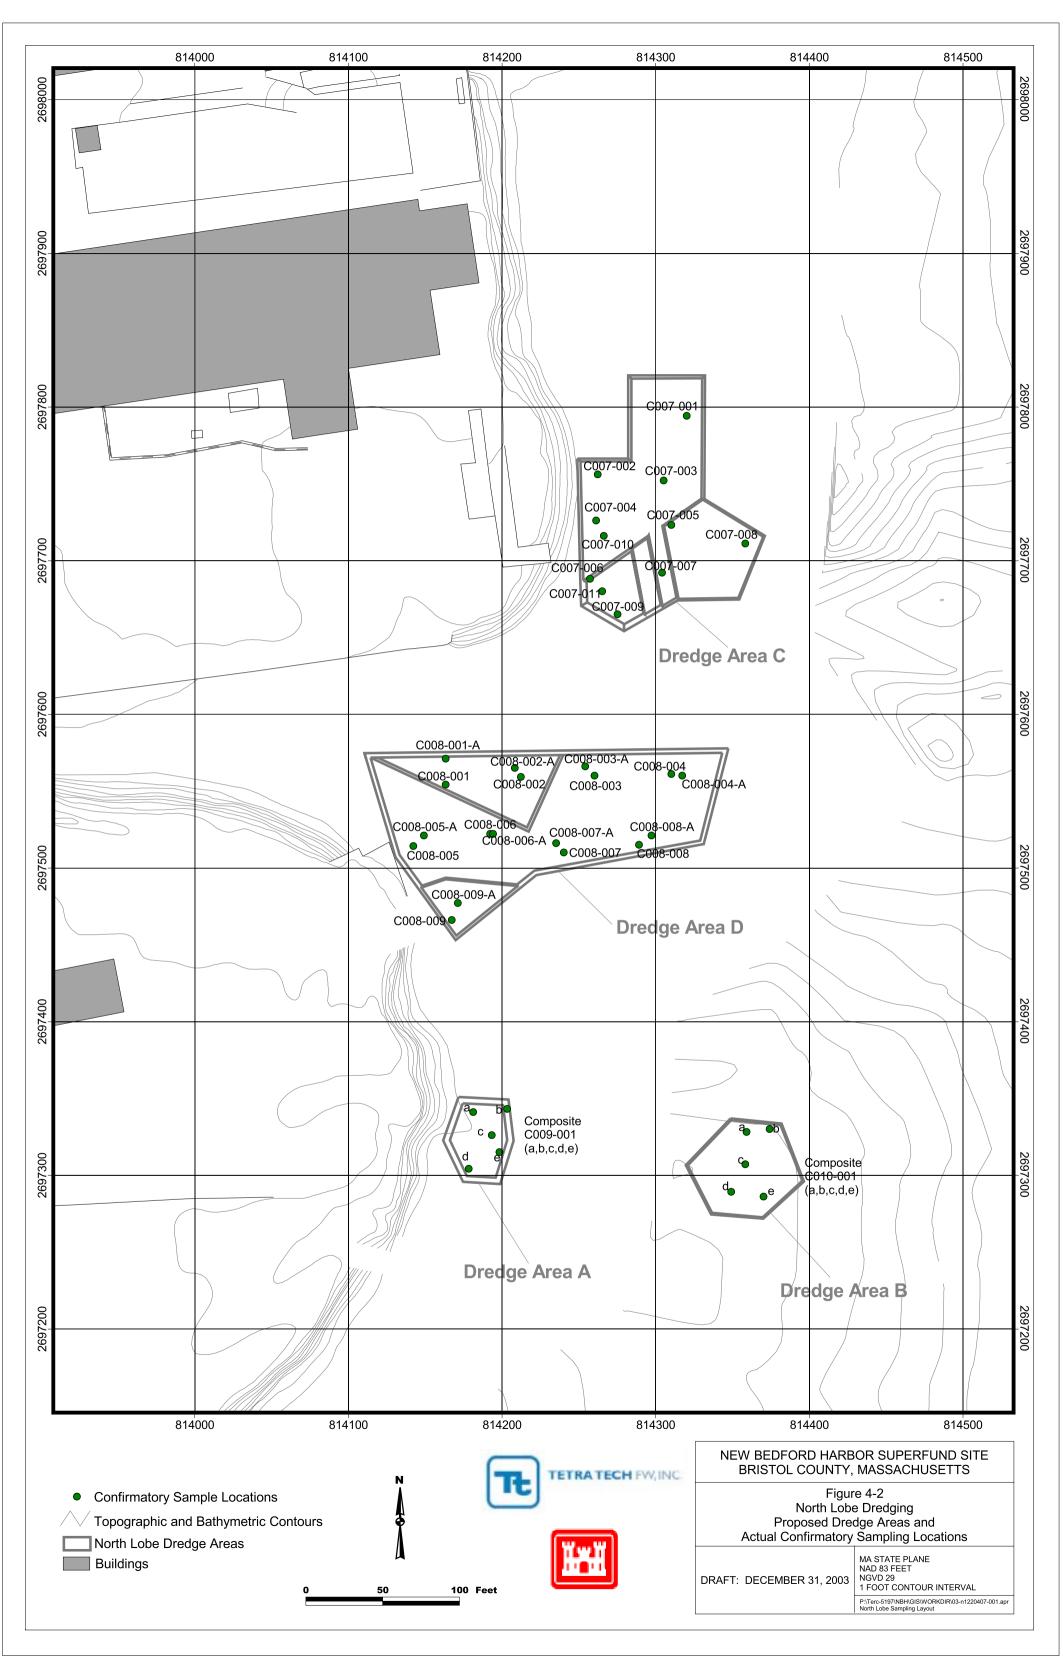
A total of 32 sample locations were included in Dredge Areas A through D. Samples were collected and tested in accordance with the Project FSP (Revision 6.1 dated August 2003) (Transmittal No. N1.01.03-01-0002) and analyzed in accordance with the Project QAPP (Revision 3.0 dated January 2003) (Transmittal No. 17.01.03-03-0005). See Appendix L.1 for North Lobe Dredging Confirmatory Sample Results Report. See Appendix L.2 for a Graphical Depiction of Confirmatory Sampling Results.
